National Transportation Safety Board Aviation Accident Preliminary Report

Location:	Hartwell, GA	Accident Number:	ERA22FA405
Date & Time:	September 10, 2022, 12:37 Local	Registration:	N3670D
Aircraft:	Beech 95-B55 (T42A)	Injuries:	1 Fatal
Flight Conducted Under:	Part 91: General aviation - Personal

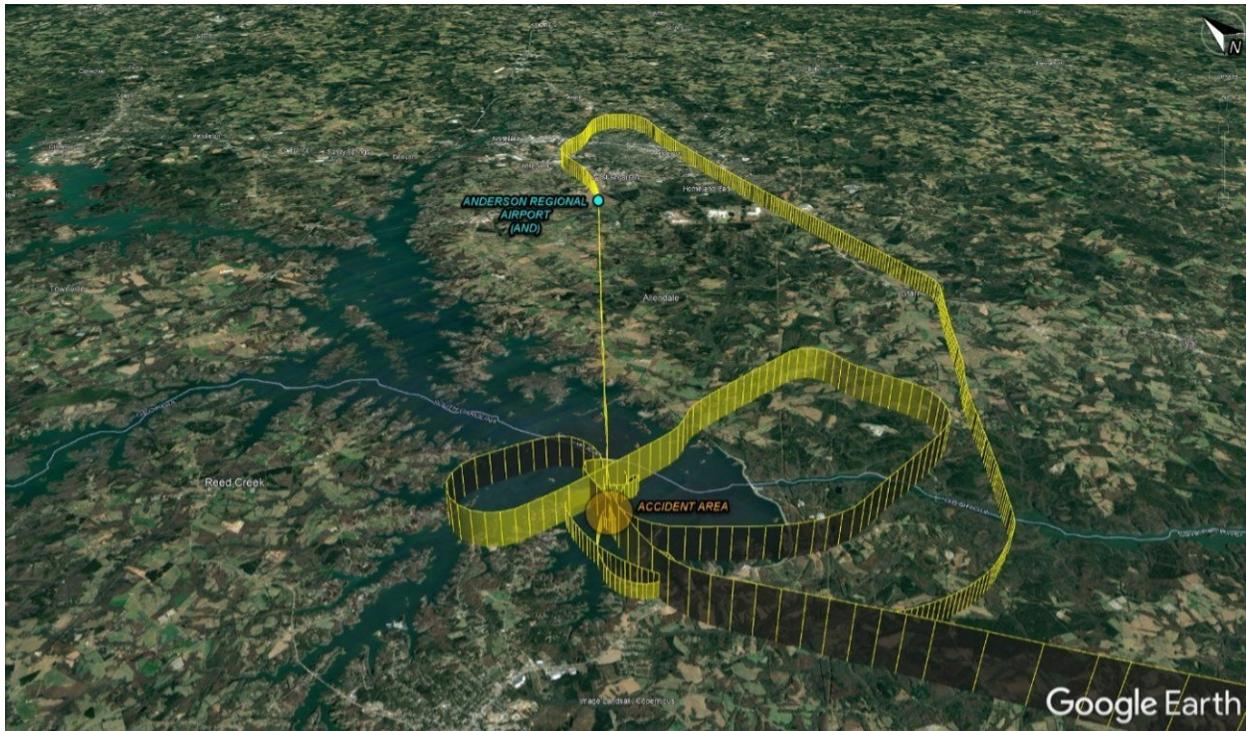
Figure 1. GPS Flight Track Overlay

According to archived flight track data, at 1235 the airplane was at 3,975 ft msl, about 30 seconds later the airplane began a right turn. The airplane completed two right turns and descended to 1,900 ft. The airplane briefly climbed to 2,750 ft msl and began a left turn. The last track data was observed at 1237, as the airplane descended through 1,825 ft msl, about 1,165 ft above ground level (agl). The airplane impacted Lake Hartwell about 9 nautical miles south of the AND airport. (See figure 1.)
